## **TECHNICAL MEMORANDUM IN-WATER REMOVAL WORK**

**Bradford Island Landfill  
Cascade Locks, Oregon**

**October 2002**

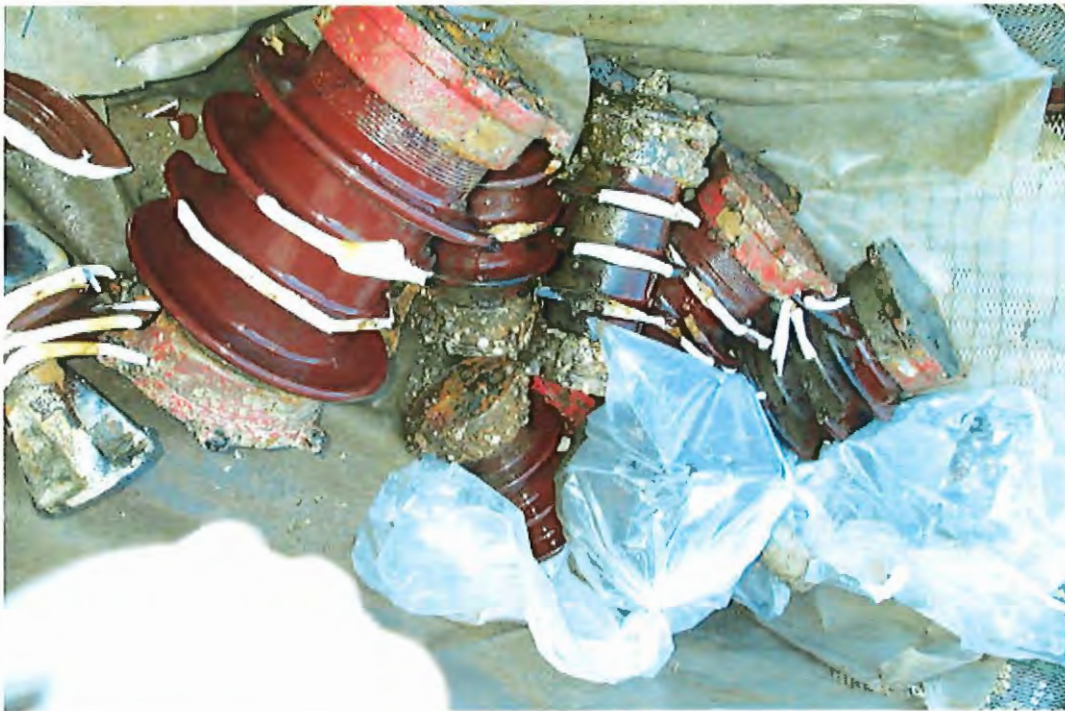
<b>Client Name:</b> United States Army Corps of Engineers		<b>Site Location:</b> Bradford Island	<b>Project No.</b> 52-00080001.08
<b>Photo No.</b> 1

<b>Direction Photo Taken:</b> NA			
<b>Description:</b> Bagged capacitor and coupling capacitors.

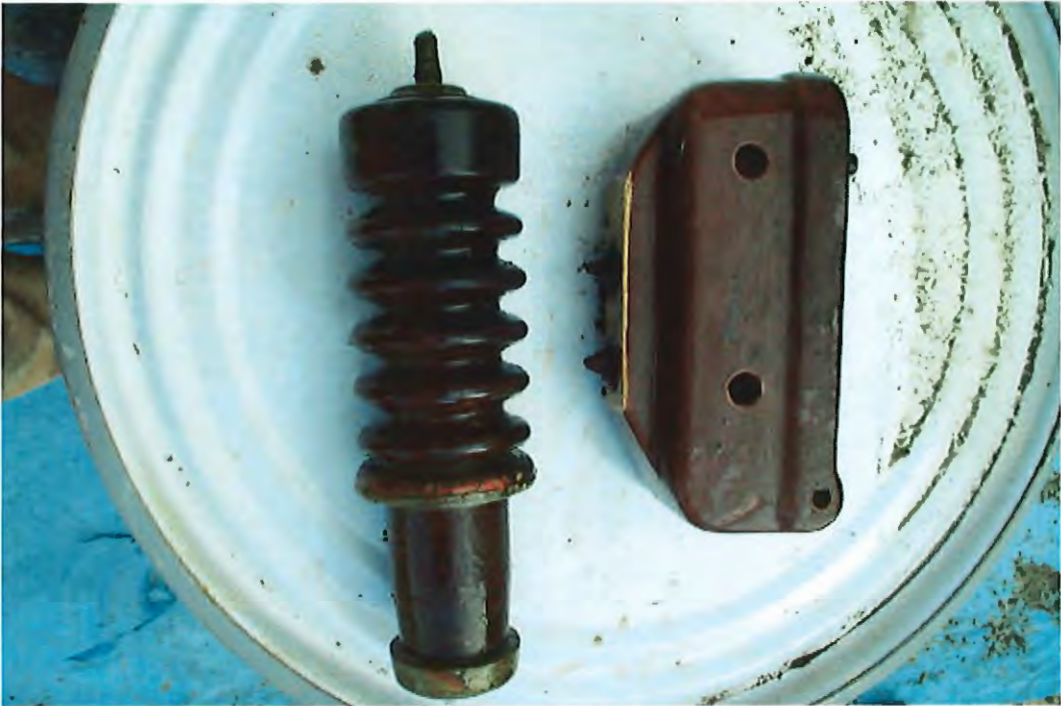
<b>Client Name:</b> United States Army Corps of Engineers		<b>Site Location:</b> Bradford Island	<b>Project No.</b> 52-00080001.08
<b>Photo No.</b> 3

<b>Direction Photo Taken:</b> NA			
<b>Description:</b> Ceramic pieces.

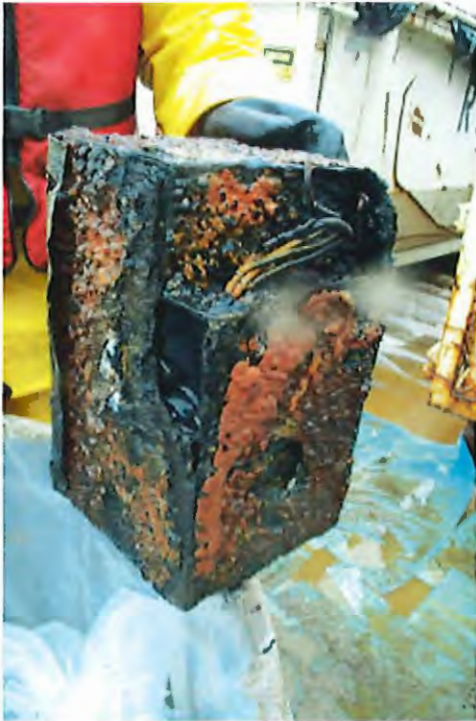
<b>Client Name:</b> United States Army Corps of Engineers		<b>Site Location:</b> Bradford Island	<b>Project No.</b> 52-00080001.08
<b>Photo No.</b> 5

<b>Direction Photo Taken:</b> NA			
<b>Description:</b> "Black Box" ballast.

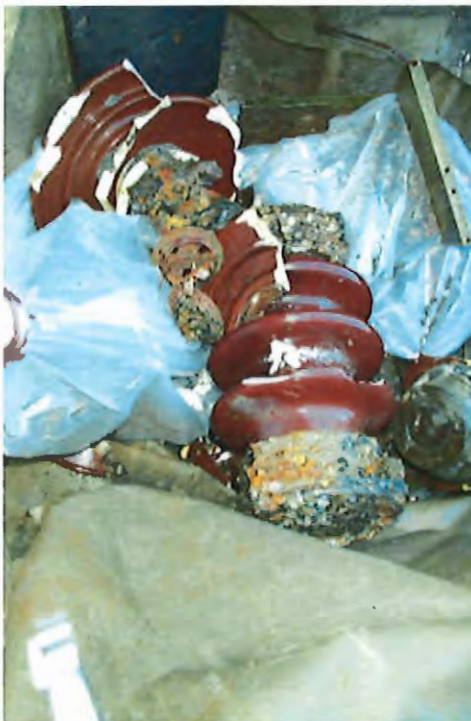
Bagged capacitors and lightning arrestor in box.

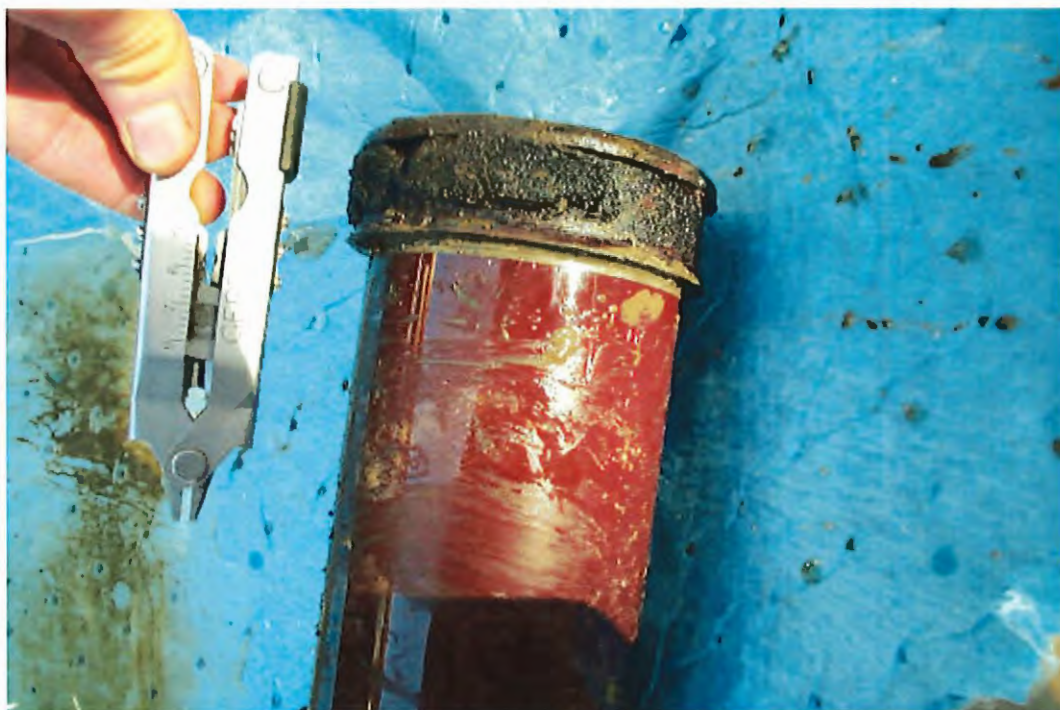
**Photo No.**

Closeup of disk inside lightning arrestors.

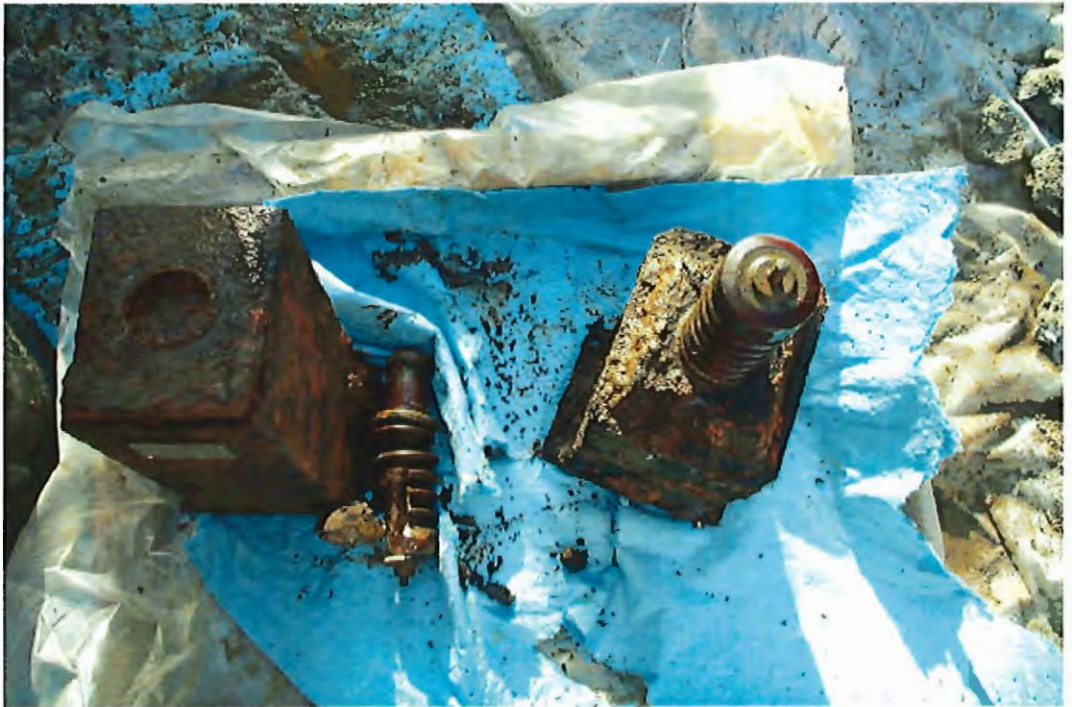
<b>Client Name:</b> United States Army Corps of Engineers		<b>Site Location:</b> Bradford Island	<b>Project No.</b> 52-00080001.08
<b>Photo No.</b> 9

<b>Direction Photo Taken:</b> NA			
<b>Description:</b> Inerteen capacitors.

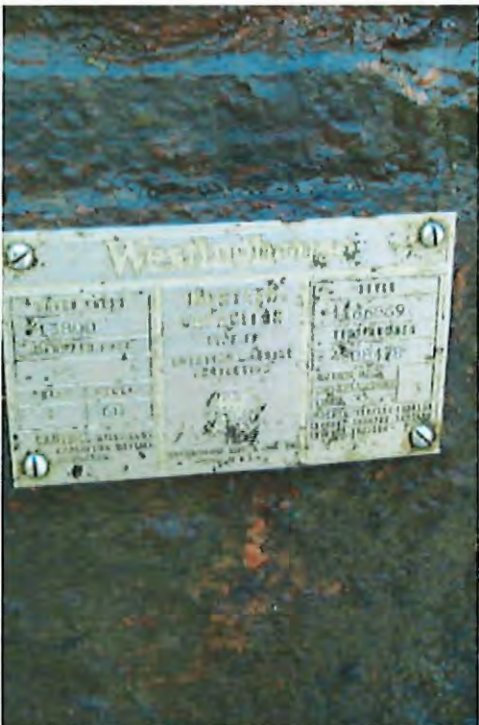
<b>Client Name:</b> United States Army Corps of Engineers		<b>Site Location:</b> Bradford Island	<b>Project No.</b> 52-00080001.08
<b>Photo No.</b> 11

<b>Direction Photo Taken:</b> NA			
<b>Description:</b> Closeup of label from an interteer capacitor.

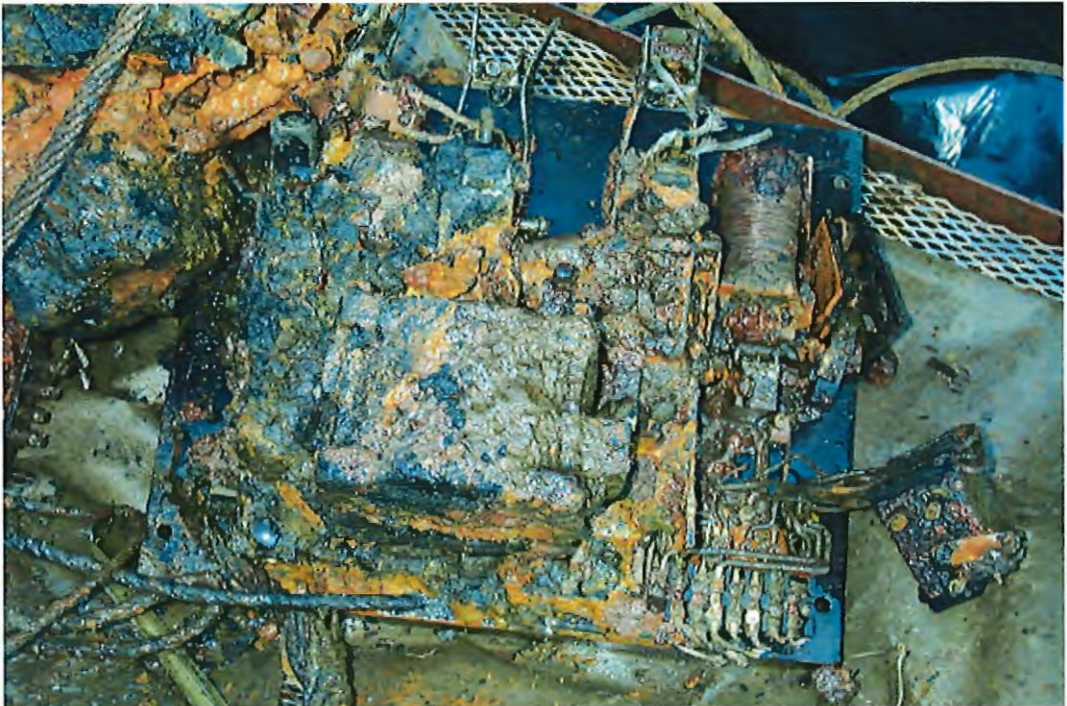
<b>Photo No.</b> 14

<b>Direction Photo Taken:</b> NA			
<b>Description:</b> Control panel.

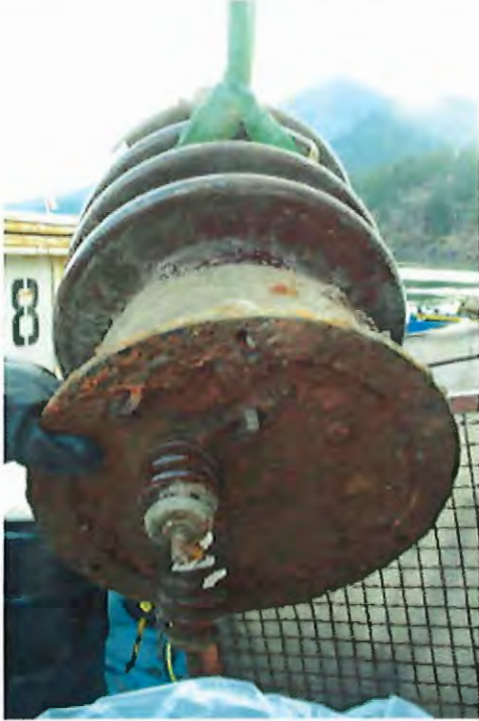
<b>Client Name:</b> United States Army Corps of Engineers		<b>Site Location:</b> Bradford Island	<b>Project No.</b> 52-00080001.08
<b>Photo No.</b> 15

<b>Direction Photo Taken:</b> NA			
<b>Description:</b> Top view of a coupling capacitor.

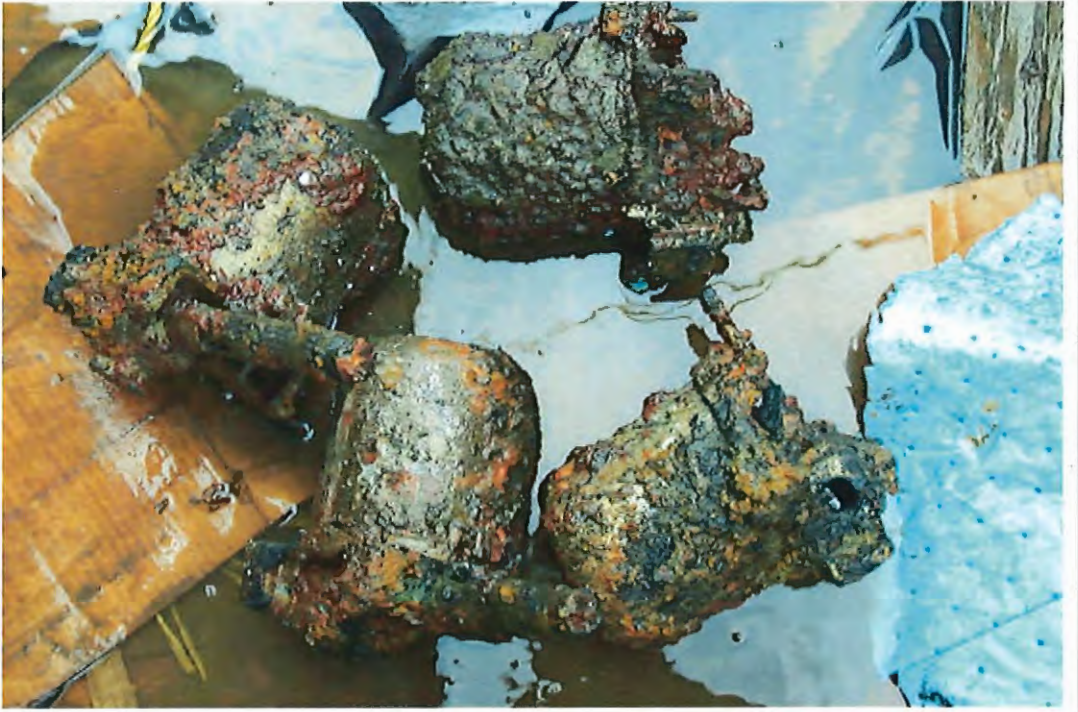
<b>Client Name:</b> United States Army Corps of Engineers		<b>Site Location:</b> Bradford Island	<b>Project No.</b> 52-00080001.08
<b>Photo No.</b> 17

<b>Direction Photo Taken:</b> NA			
<b>Description:</b> Oil-filled switches.

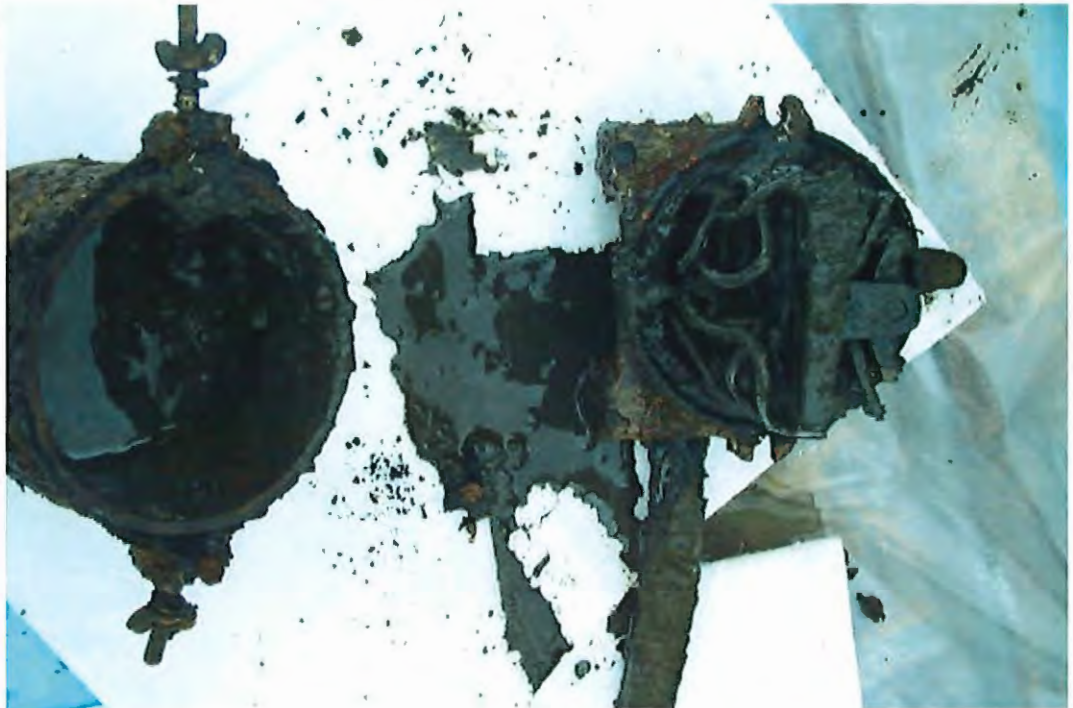
Opened oil-filled switch.

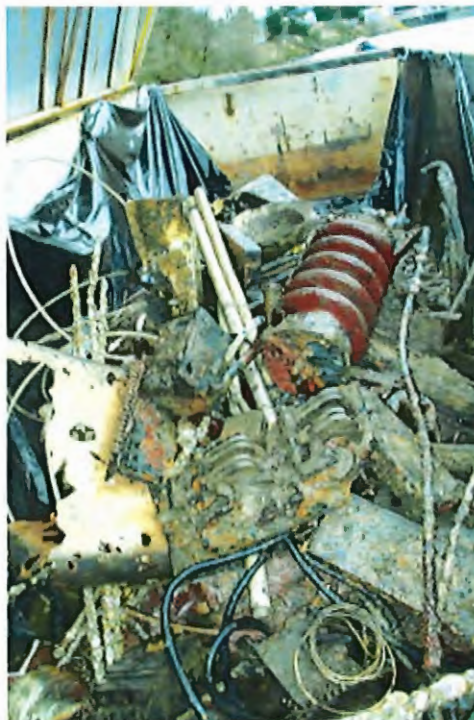
Miscellaneous metal and lightning arrestor.

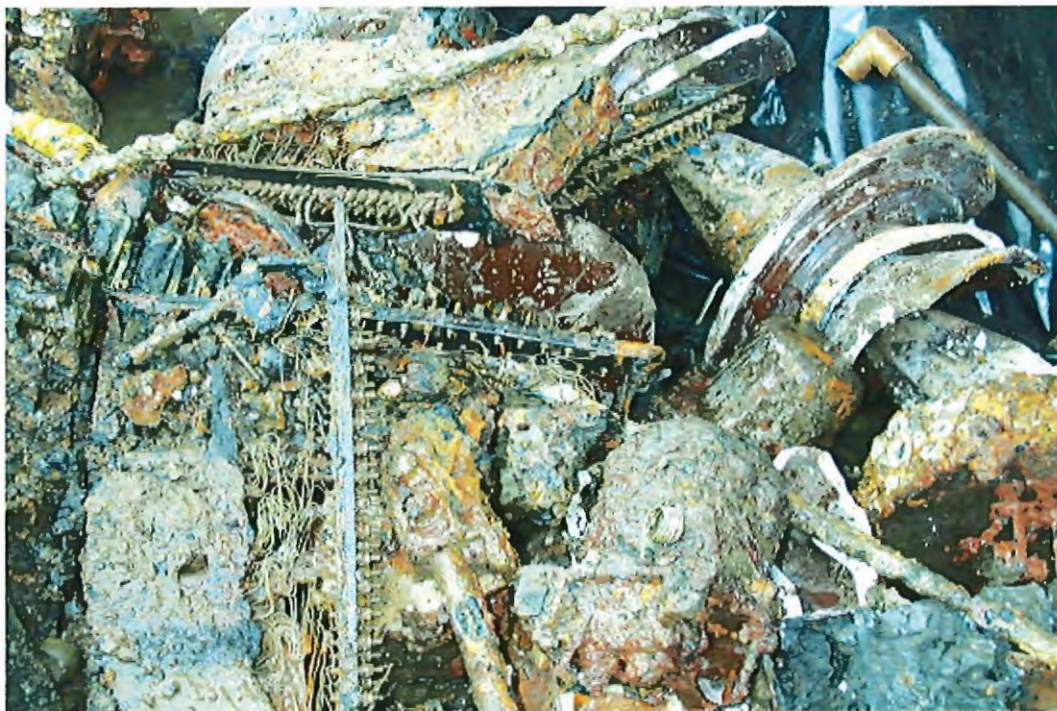
Communication boxes and post insulator.

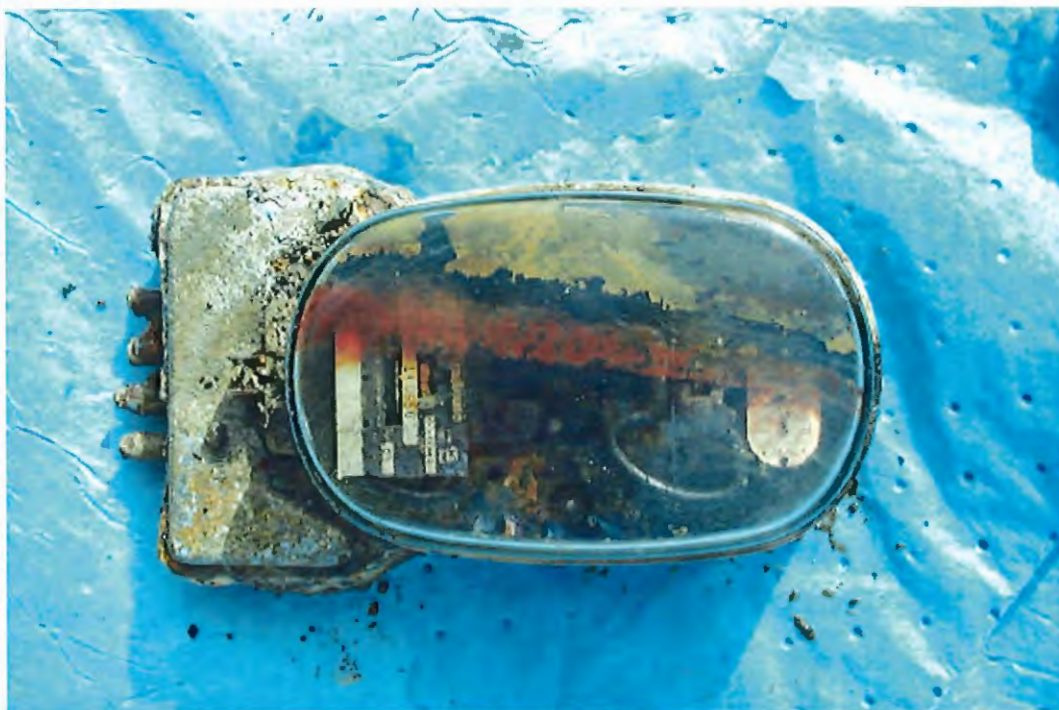
Electric meter.

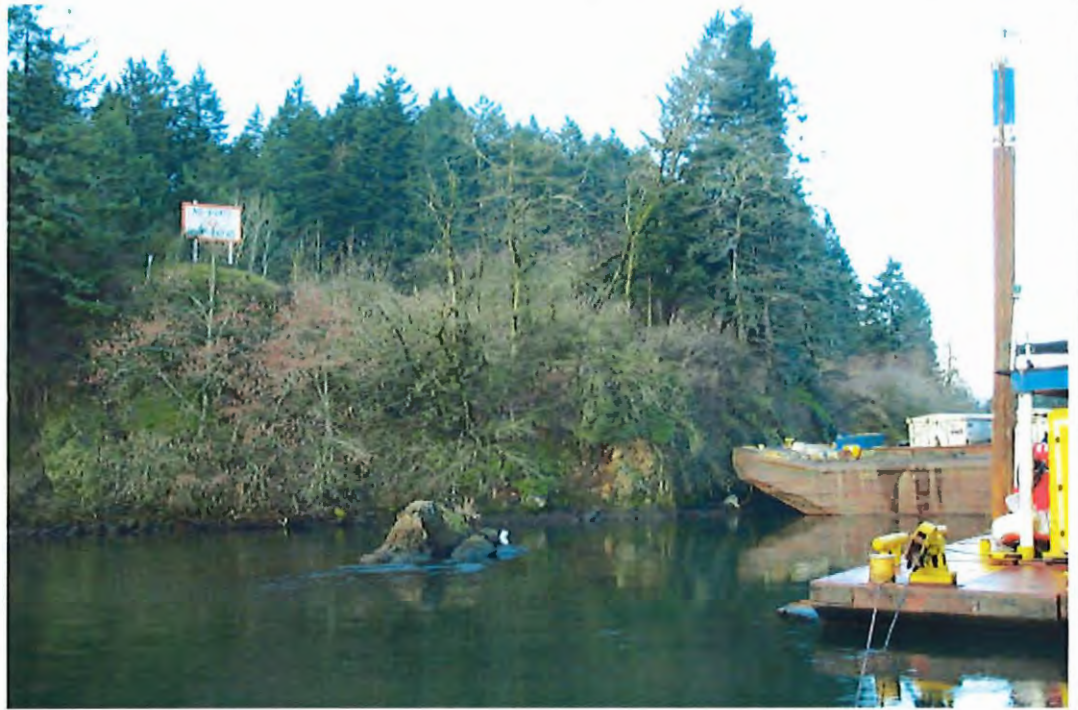
Barge set up on Pile #1.

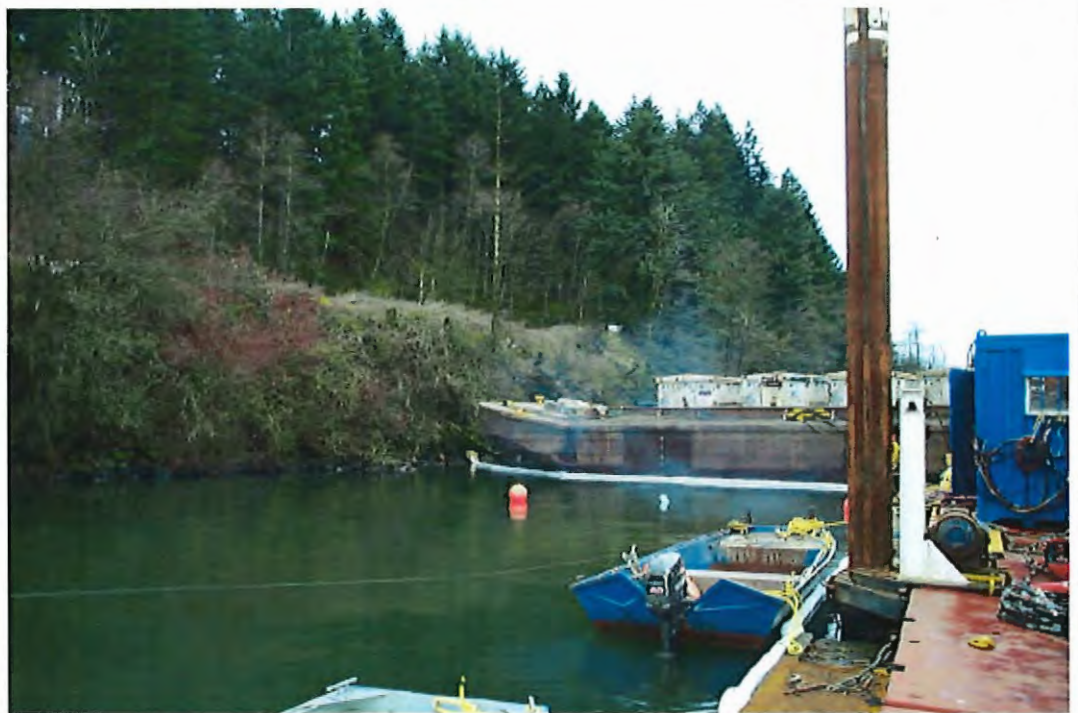
Barge set up on Pile #2.

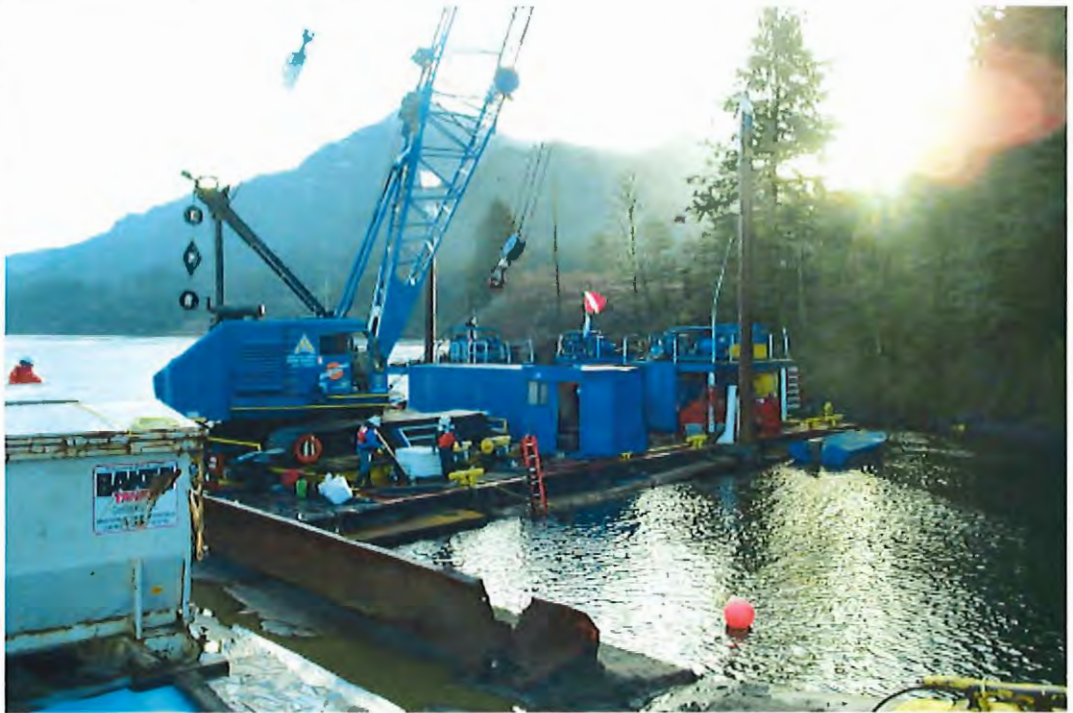
Barge set up on Pile #3.

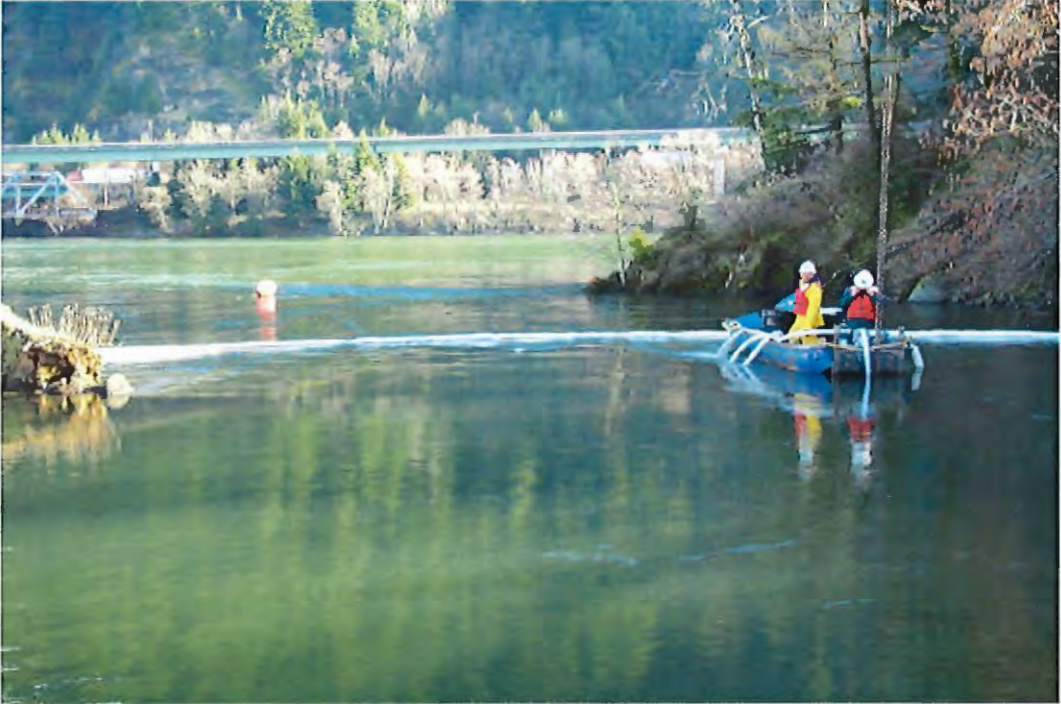
<b>Client Name:</b> United States Army Corps of Engineers		<b>Site Location:</b> Bradford Island	<b>Project No.</b> 52-00080001.08
<b>Photo No.</b> 27

<b>Direction Photo Taken:</b> South			
<b>Description:</b> Sediment removal at Pile #1.

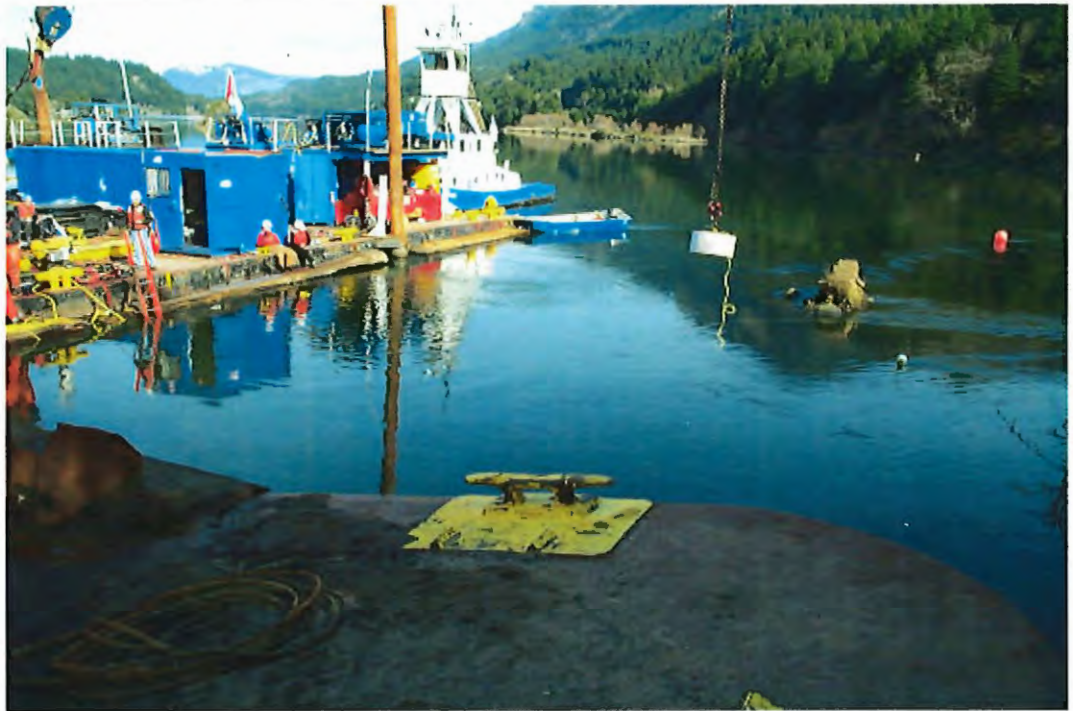
Placing anchors at Pile #1.

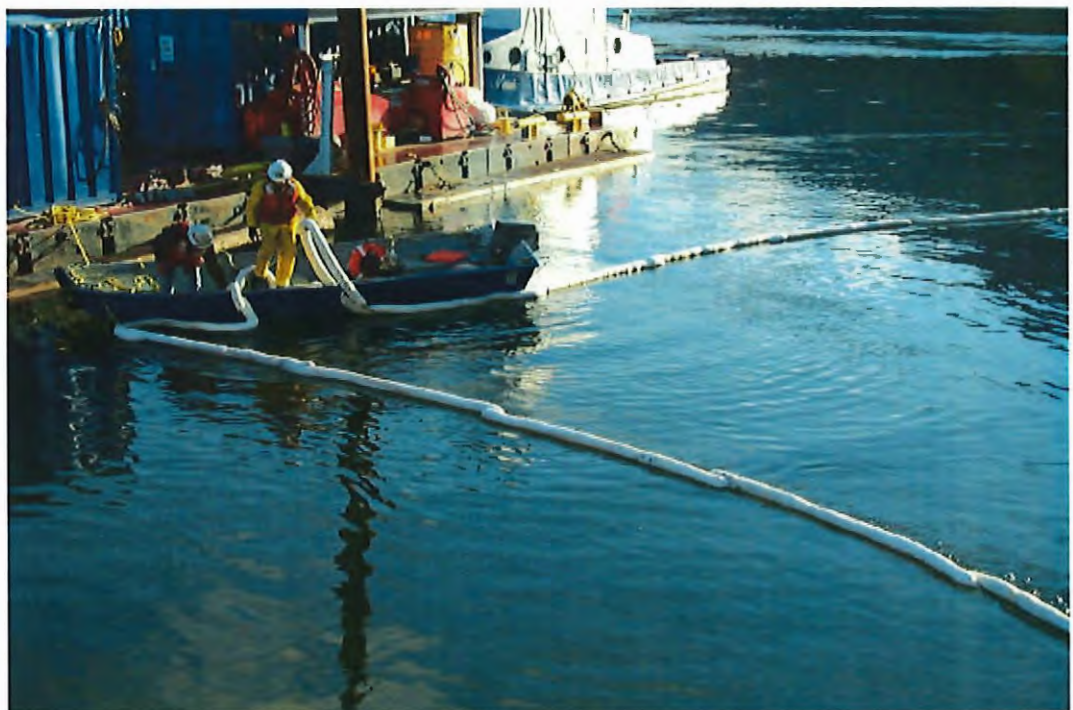
Placement of oil boom at Pile #1.

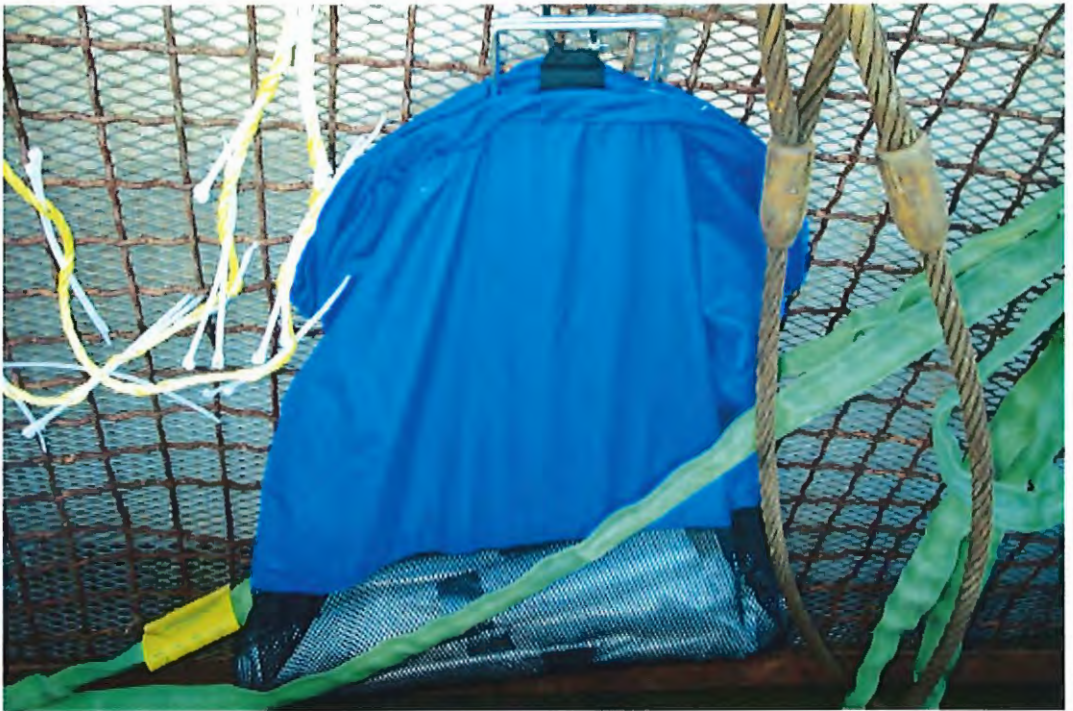
<b>Client Name:</b> United States Army Corps of Engineers		<b>Site Location:</b> Bradford Island	<b>Project No.</b> 52-00080001.08
<b>Photo No.</b> 31

<b>Direction Photo Taken:</b> NA			
<b>Description:</b> Closeup of lined wire basket and goody bag.

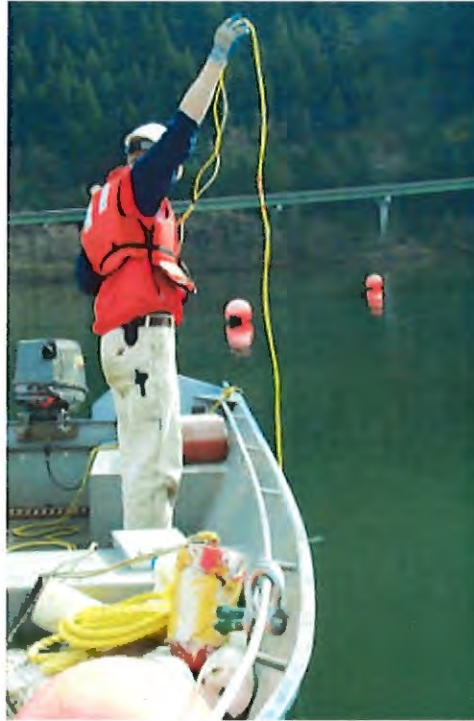
Placing turbidity probe in water.

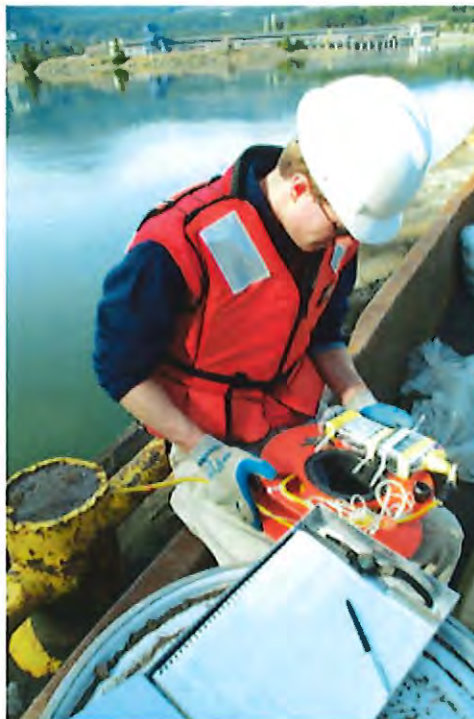
Closeup of turbidity meter and monitoring.

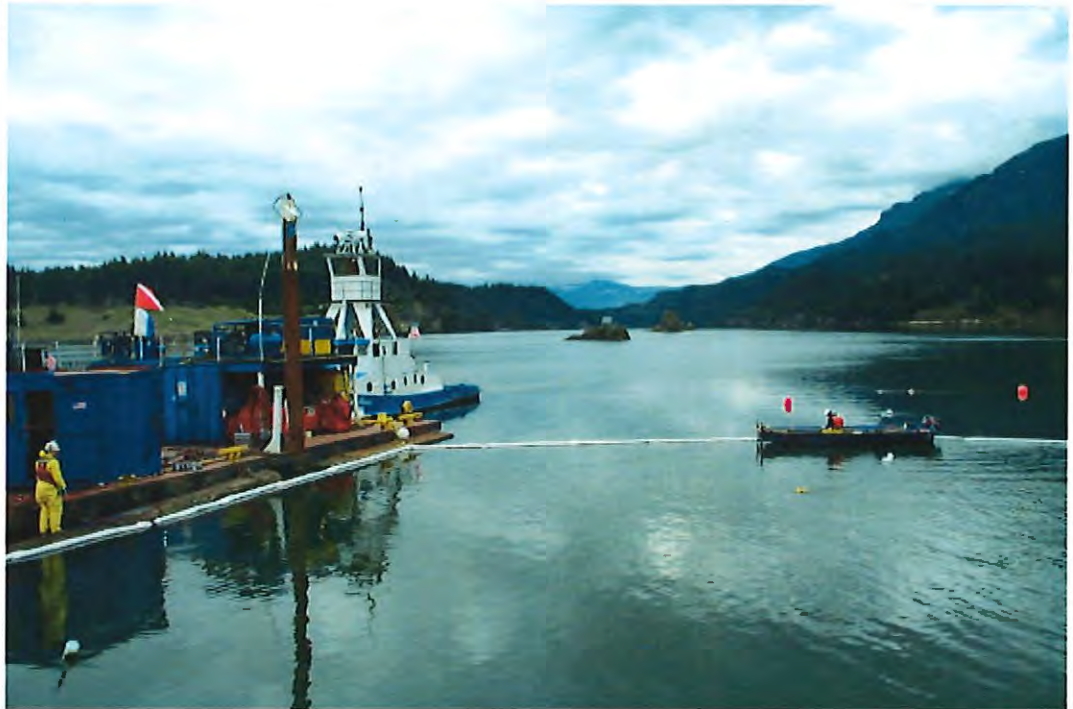
Turbidity monitoring at Pile #1.
